## The Automotive Research Association of India

1	AEPL'S CREW SEAT		
Report No.	SDL/3100021589(24-25)/AEPL/305(24-25) Part II		Date: 30/12/2024	
Name of the Party	Autogistic Engineering Private Limited (AEPL) No. 267/1, Podhigai, Big Melamaiyur Villam Post, Thirukalukundram Road, Chengalpattu, Kanchipuram - 603002			
REFERENCE				
Correspondence Reference:		E-mail dated – 14/08/2024		
Specifications Reference:		FMVSS 210		
TEST COMPO	NENTS			
Crew seat		3100021589/07		
Test Date		03/12/2024	03/12/2024	
	USED

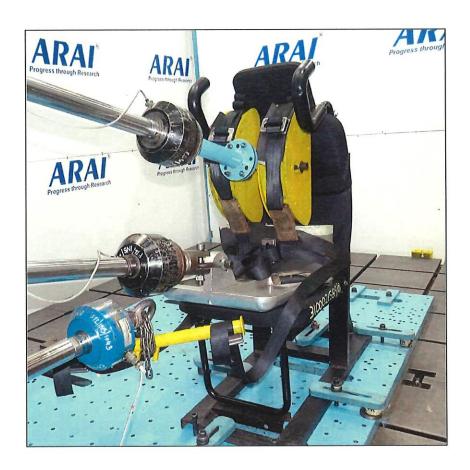
Deformation of seatback has been observed in the direction of load. Fig. 02 shows after test photographs.

Fig. 02 – Post test photographs of Crew seat. (Component ID: 3100021589/07)

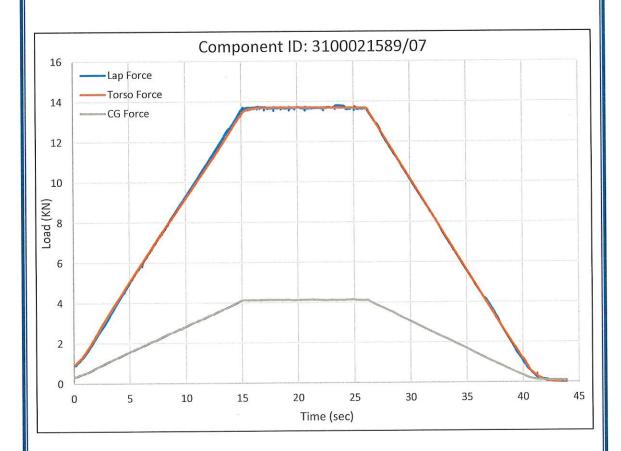
Seat achieved and sustained loads for period of 11 seconds.

Fig. 03 – Load vs. time graph acquired during SBA test of Crew seat
